Pre-Purchase Building Report

13 West Street,

Bexley

Pre-Purchase Inspection - Residential Building Report

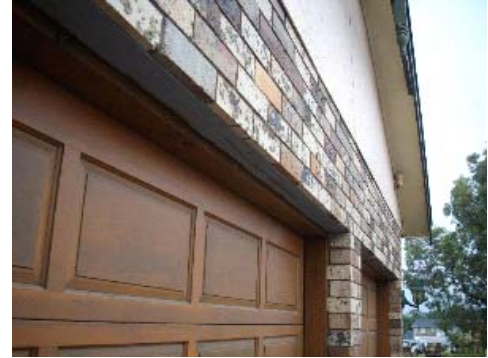
- Arch bars are galvanised.

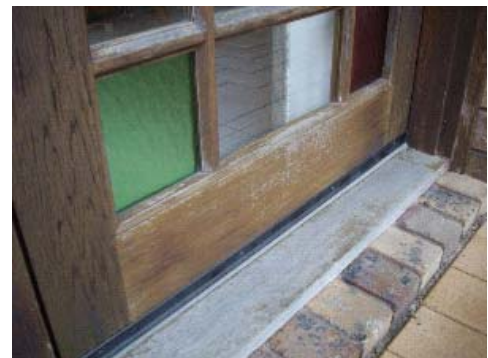
- Paintwork has aged and weathered.

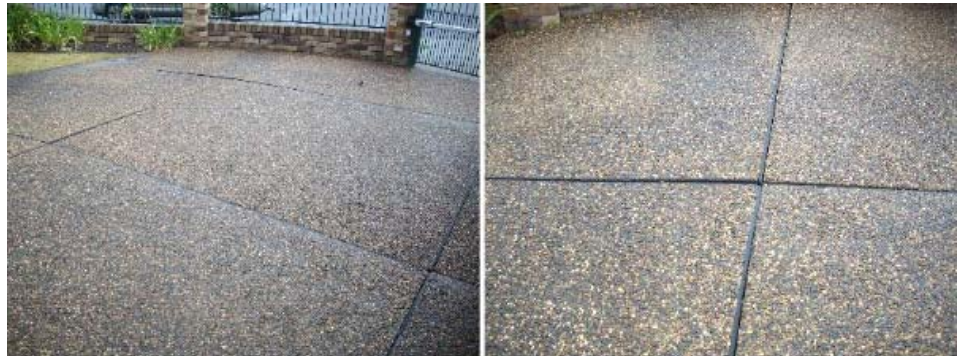
- The concrete is lifting - minor.

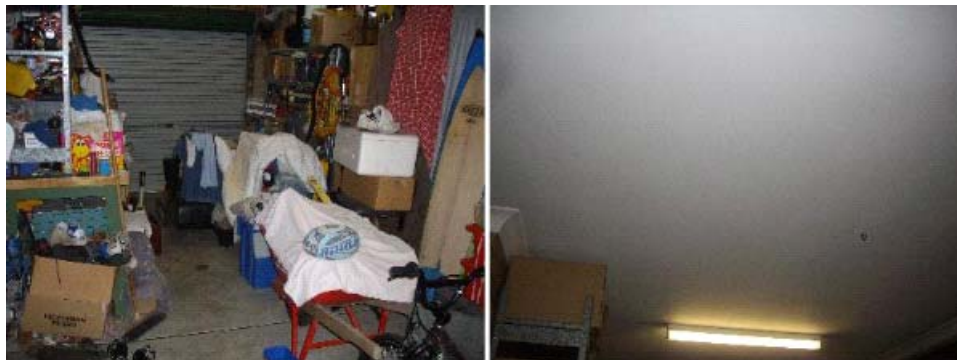
- Poor joint setting was noted to ceiling lining.
- Sagging was noted to the ceiling lining. This may be the result of lack of adhesion to joists.

The following items may require the attention of a licensed tradesman.	
1. Resecure sagging garage ceiling prior to painting and re set joints.	\$500
2. Re set loose toilet pan	\$200

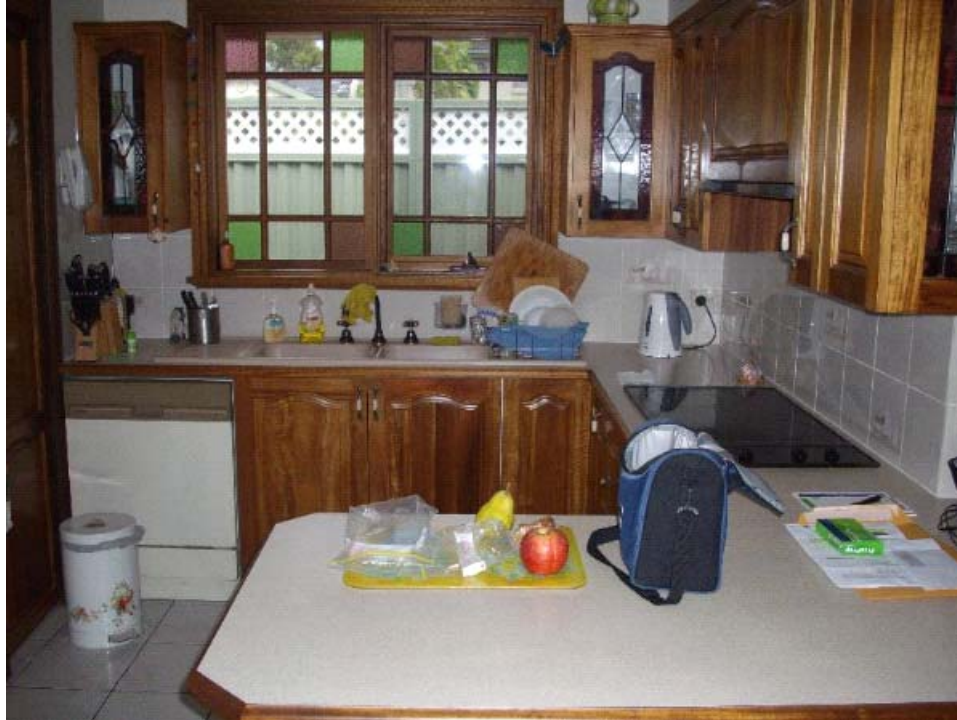
- Cupboard door hinges are out of adjustment.
Wear and tear to doors noted

We recommend you arrange for a handyman/tradesman to rectify the following minor repair items	
1. Adjust striker plates to internal doors. 2. Adjust kitchen cupboard doors. 3. Remove timber formwork to sub floor area	
Overall allow :	\$500

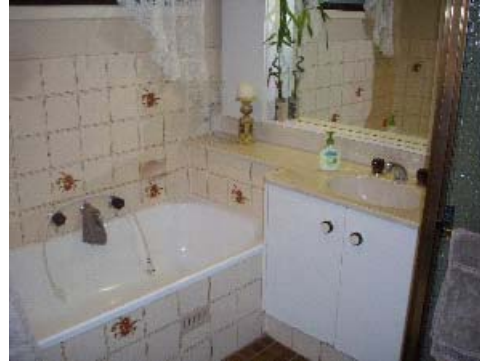
- Wear and tear is noted to the vanity cabinet.
- The vanity unit is nearing the end of its economic life and replacement should be considered.

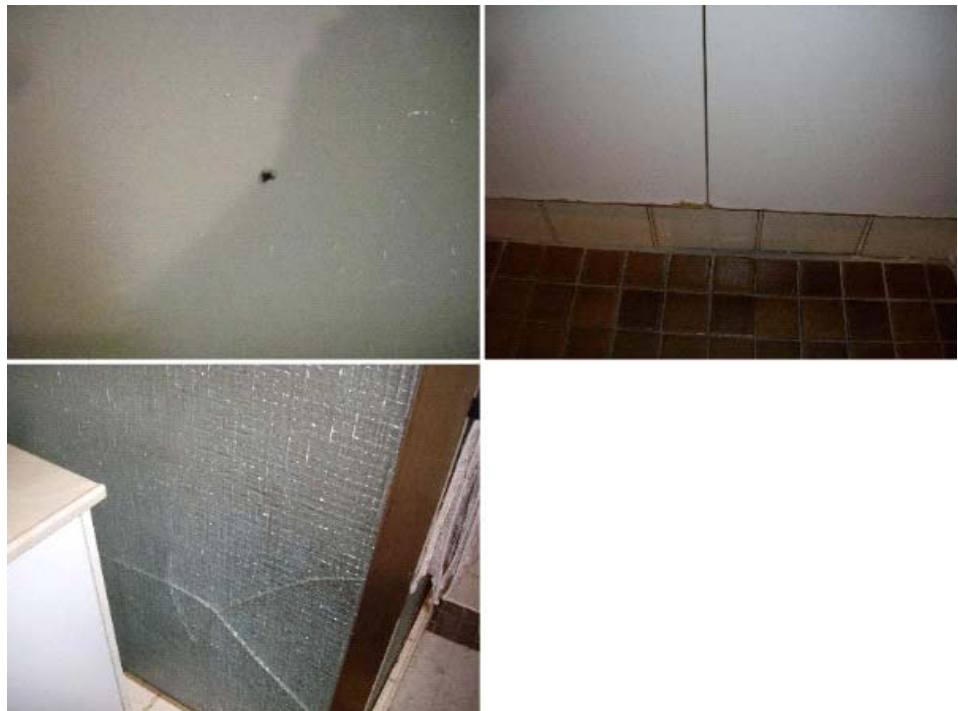
- The shower recess was tested and there was no visible water penetration to surrounding areas at the time of inspection.
- Glass in the shower screen is cracked.
- The shower recess is nearing the end of its economic life.
- Bath tub enamel is chipped.
- The bath has reached the end of its economic life and replacement should be considered.

The following items should be subject to a further detailed investigation by a licensed tradesman to enable an accurate estimate of cost to be provided.	
1. Renovation of bathroom

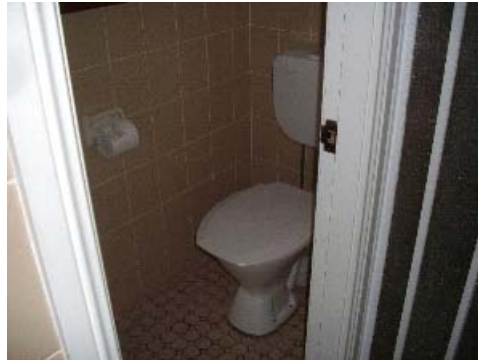
- The toilet pan is loose at the floor and needs to be re-set.

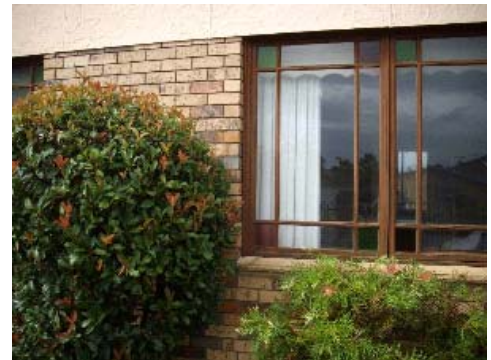
- Settlement cracks to brickwork - Appearance defect

If settlement cracks or gapping exist, the only way to determine whether movement has ceased is for the cracks/gaps to be monitored over a period of time. If future movement ranges more than about two or three of millimetres, a structural engineer should be consulted.
